# Manhole Inspection Summary

Manhole # S33WW\_001MH

Insp Date: **4/13/07 12:23 PM**

**Location** Address: **3001 LOVEGROVE ST**

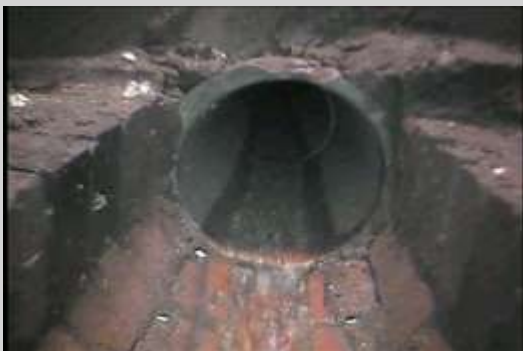
### 8 in. Circular Gravity Sewer Pipe In @ 6 O'Clock

Rod and Bar (Angled)

Infiltration: **None** Pipe Seal Cond: **Unknown**
